Housing

*Wear test of mechanical parts
and vinyl floor
of the 2x2GM160 Library system*

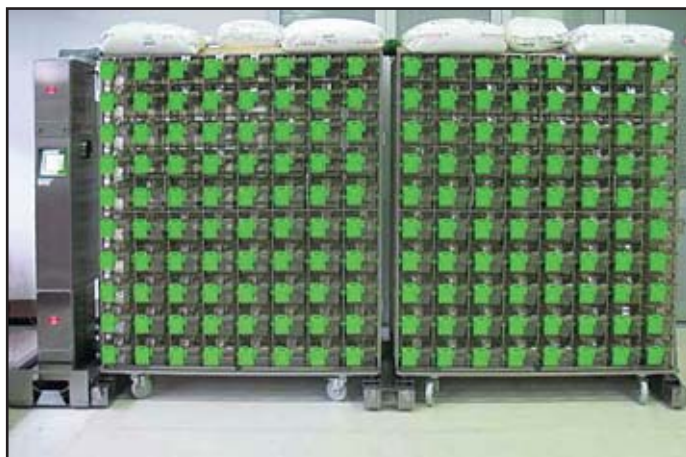
Picture 1: library configuration used in the test. It is composed of 2x2GM160 racks, an Air Handling Unit, the lifting platform and a load to simulate animals, bedding, food and water. The system moves along a vinyl floor.

Two 2GM160 racks and an Touch Slim Plus Air Handling Unit (AHU) were used to make up the library configuration. The weight of each single rack, with empty cages and bottles, is 435 kg. To simulate animal, bedding, food and water weight for 320 cages, a 130 kg load was applied on the racks. Racks were connected to the AHU and the system was lifted by the special platform (*picture 1*). The total weight of the system library-load-platform was about 1450 kg. The test was carried out with an ambient temperature of approximately 24°C and relative humidity of around 50%. The vinyl floor temperature was approximately 23.5 °C. The library movement was carried out along a rail (*picture 2*).

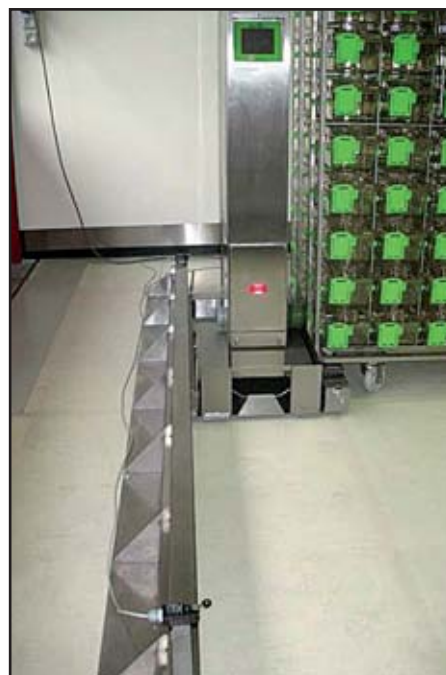
Picture 2: library runs along a rail to fix the direction of movement.

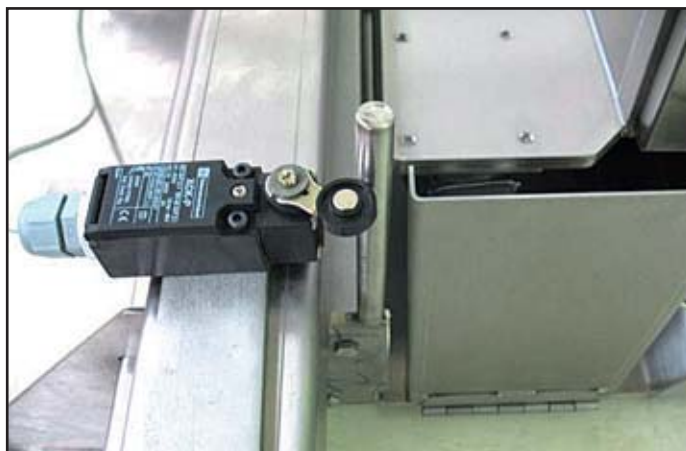
Picture 3: end run interrupter to invert direction and count cycles.

The automatic control system was equipped with two electro-mechanical interrupters (*picture 3*) to invert the rotation of the motor and thus the running direction of the library. The interrupter also triggered the cycle-counter. A cycle was defined as twice the distance between the two interrupter, equal to 1.568 m (61.7 in). The time of one movement in one direction was 1 minute and 1 second, with the platform moving at 25.7 mm/s (1.0 in/s). After an 11 second pause, the system changed direction. Each cycle lasted 2 minutes and 24 seconds.

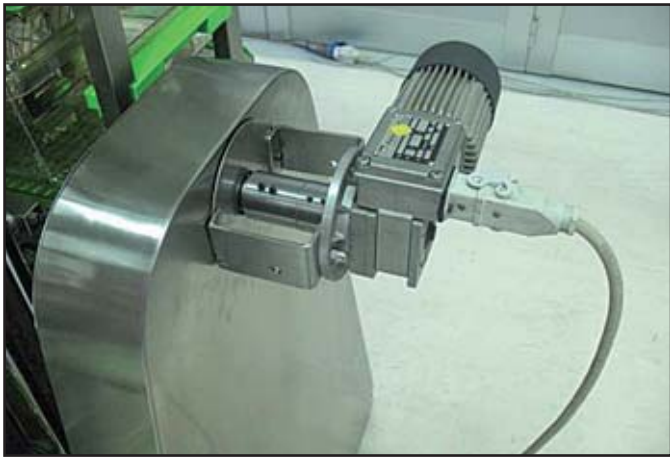
Picture 4: automation system. Motor (on the left) and control system with cycle counter (on the right).

Picture 4 shows the 9 Nm and low power motor (on the left) and the electrical control system. The test was interrupted periodically to check the state of wear of the materials. The system was stopped at times for some hours to check the imprints left on the vinyl floor.
